12/13/2018

From: Deb Hummel and Jessie Olson, Lefthand Watershed Oversight Group

RE: Monitoring to determine effectiveness of post-flood restoration on Left Hand Creek, Boulder County, Colorado

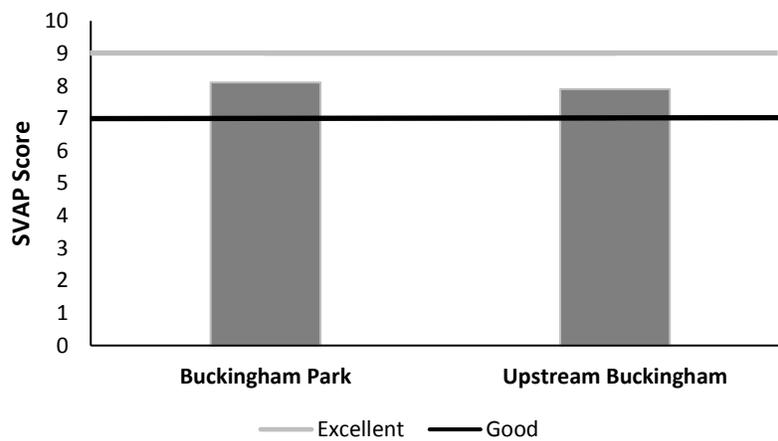
SVAP and LWOG site monitoring form observations provided an overall characterization of the study reaches. The SVAP score is an average of 16 geomorphic and biological elements individually scored from 0 to 10, 10 being the highest performing condition. The Buckingham Park control reach and Upstream Buckingham restored reach received similar SVAP scores of 8.1 and 7.9, respectively. Both values are within the good stream condition classification ranging from 7.0 to 8.9 (Figure 2). We hypothesized that restored sites would have less flood resilience one year after restoration compared to control sites. These results were in line with our expectation that the Upstream Buckingham site would have a lower overall SVAP score than the control site. Upstream Buckingham scored lower due to vegetation gaps, while Buckingham Park had greater cover and percentage of native species. The SVAP score was an important tool for preliminary reach-wide assessment, but further monitoring efforts were needed to identify and assess geomorphic and biological characteristics between reaches.

Figure 2. The 2018 overall SVAP scores for Buckingham Park and Upstream Buckingham reaches on Left Hand Creek, Boulder County, Colorado.

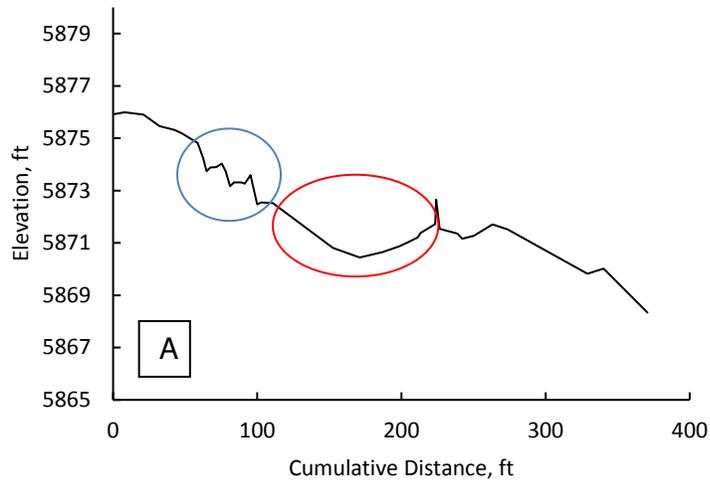
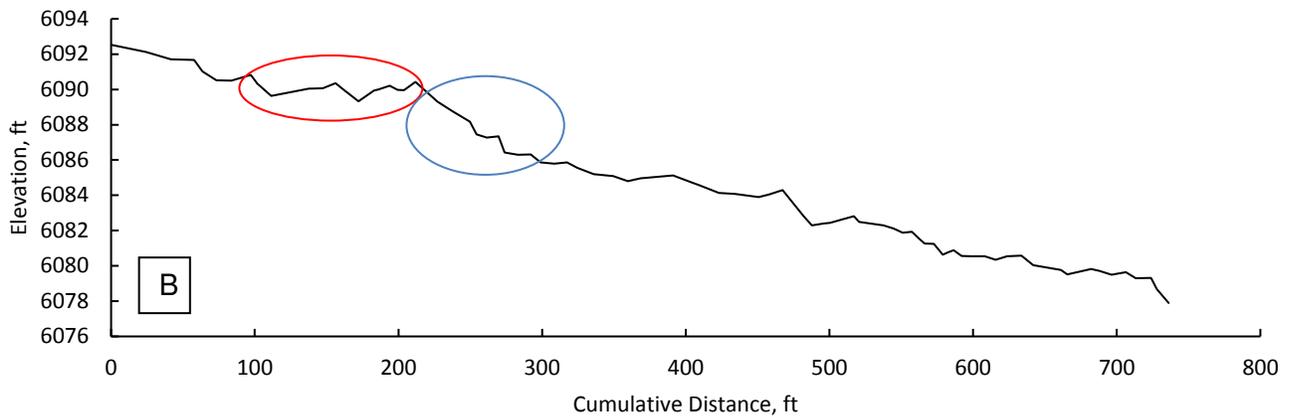
Both Buckingham and Upstream Buckingham reaches are characterized as canyon streams. Both sample reaches included a pool and riffle. A longitudinal profile was measured along the thalweg of each reach (Figure 3). The lengths of each profile were dependent on sampling equipment and satellite communication. The 375 ft. long profile for Buckingham Park illustrates a continuous riffle followed by a series of step pools and a 125 ft. long pool beginning at 100 ft. cumulative distance. The reach then continues with a continuous riffle. The 750 ft. long profile for Upstream Buckingham illustrates a riffle followed by a 100 ft. pool beginning at 100 ft. cumulative distance. The channel then follows a short step pool complex and a long continuous riffle. At 715 ft. cumulative distance, the long profile illustrates the crest of a second pool. Similarly, the maximum water depth at both pools were greater than 33 inches and deposition of fine sediment was observed.

Figure 3. The 2018 longitudinal profiles for A. Buckingham Park and B. Upstream Buckingham sample reaches on Left Hand Creek, Boulder County, CO. Red circle indicates a pool and blue circle indicates a step pool. Cumulative distance for Buckingham Park is abbreviated to scale.

2. Monitor flushing flows, encroachment, and stream profile at Upstream Buckingham in comparison with Buckingham Park

The flushing flow rates and restored bankfull channel widths of upper Left Hand Creek are influenced by man-made alterations. Below the James Creek and Left Hand confluence, restored channel widths must account for flow regimes effected by inputs from Left Hand Reservoir and the diversion from South St. Vrain through James Creek. If flushing flow events are inadequate for these restored bankfull channels, then mature riparian vegetation may establish on the exposed alluvial substrate. This encroachment may armor the banks and cause channel incision (Friedman 2018; Gordon and Meentemeyer 2006). Past research has also found that encroachment may be delayed for multiple years following hydraulic alterations (Jalon et al. 2017, unpublished data). While it is unclear if the low levels of herbaceous encroachment at Upstream Buckingham is indicative of a combination of inadequate channel width and altered flushing flow rates, increased encroachment may armor banks and result in channelization or incision. For these reasons, we suggest continued monitoring of riparian encroachment and revegetation in conjunction with flow observations and cross sectional profiles.

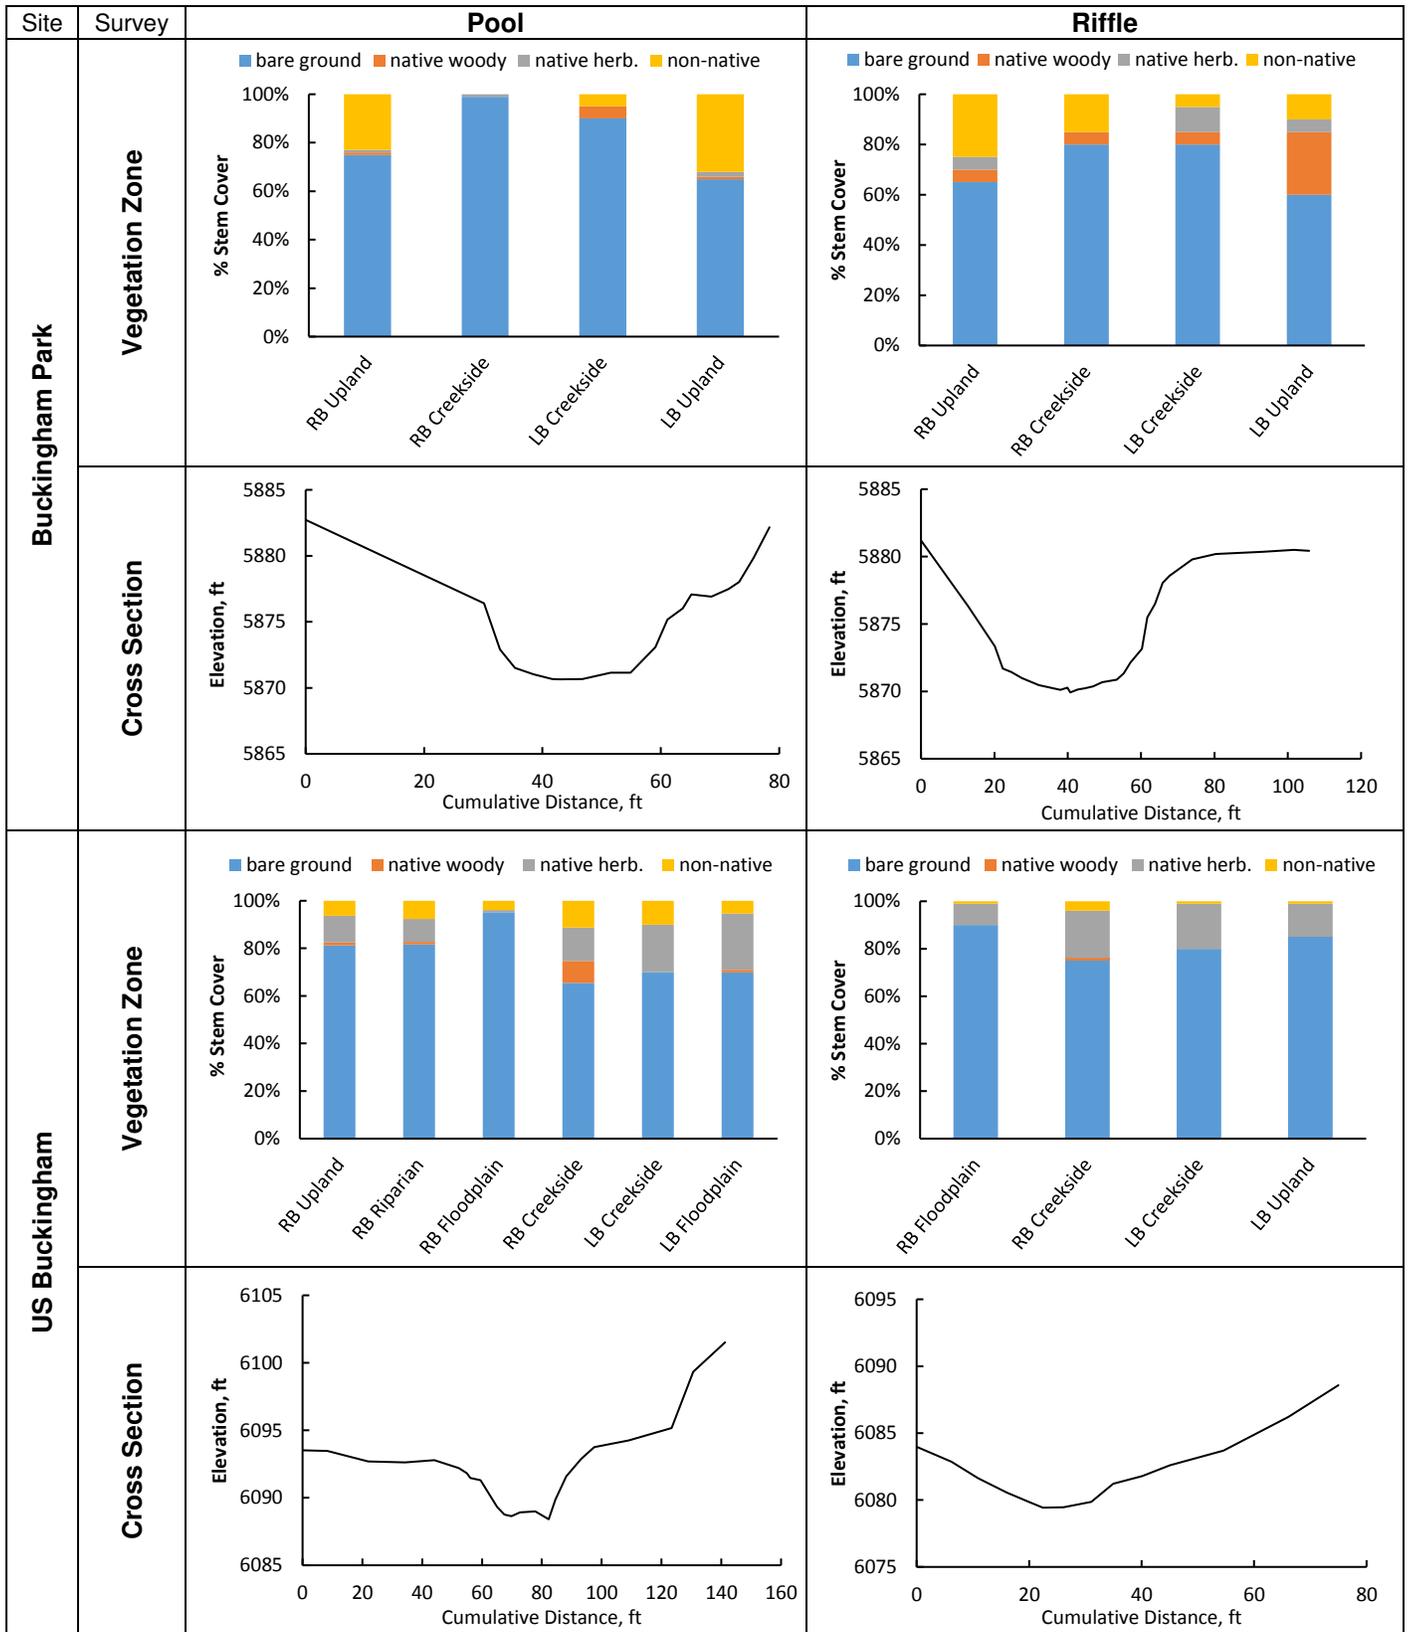
In addition, cross sectional profiles were surveyed at each pool and downstream riffle and were supplemented with pebble counts and vegetation surveys. Canyon streams are characterized by steep upland banks and these were observed at both sites. However, the channel at Buckingham Park is slightly incised due to additional constraints including Left Hand Canyon Drive and the park adjacent to the right bank (Figure 4). Upstream Buckingham reach is also constrained by Left Hand Canyon Drive on the left bank, but the channel has more access to its floodplain. Additionally, recent activation of the restored floodplain was indicated by rack lines and small wood accumulation. These comparisons and observations suggest that the restoration effort at Upstream Buckingham successfully reconnected the floodplain.

Revegetation throughout the riparian corridor after flood disturbance is critical for bank stabilization and ecological habitat. At a minimum, four vegetation zones were assigned per cross section, these included creekside and upland vegetation plots for each bank. Additional floodplain and upper riparian zones were identified and sampled at the discretion of the surveyors. We found that bare ground comprised 60% or more of vegetation zone plots for both sites (Figure 4). Overall, US Buckingham Park vegetation zones had a higher % stem cover of native herbaceous and woody plants. In contrast, Buckingham Park vegetation zones had higher % stem cover of invasive plants, with the exception of the left bank upland plot along the riffle transect.

Figure 4. The 2018 pool and riffle survey results for Buckingham Park and US Buckingham sample reaches on Left Hand Creek, Boulder County, Colorado. Composition of the vegetation zone (Upland, Riparian, Floodplain, or Creekside) is illustrated by % stem cover of bare ground, native woody, native herbaceous, and non-native plants. Banks are oriented as if the observer were looking downstream. Cross sections for each pool and riffle are plotted by elevation (ft) and cumulative distance (ft). Profiles are oriented as if the observer were looking upstream. Vegetation Zone charts and Cross Section graphs are directly correlated by cumulative distance, but rather rough estimates.

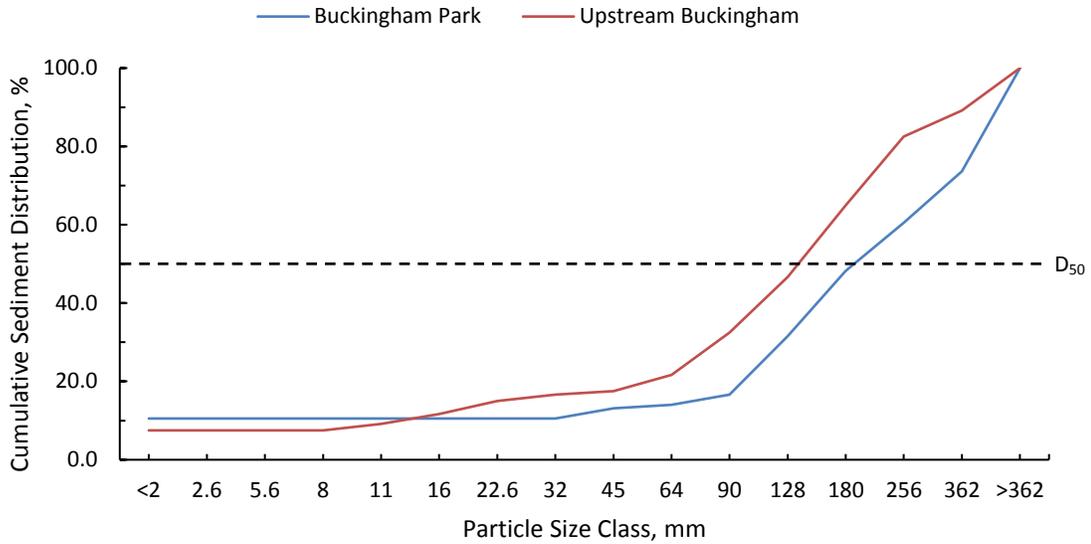
Sediment size and distribution further characterized bankfull substrate at the pool and riffle sites. Theoretically, the median cumulative 50% (D_{50}) sediment distribution corresponds with the substrate particle size (mm), and every particle size less than, that will mobilize at bankfull flushing rates without larger obstruction such as large boulders (Wolman 1954). At the riffle cross sections, the D_{50} particle size was 128 mm at Upstream Buckingham, while the D_{50} particle size at Buckingham Park was 180 mm (Figure 5). Overall, both sample reaches had similar substrate size distribution. The smaller median size at Upstream Buckingham is reflective of a higher relative frequency of cobbles (>64- 256mm), while Buckingham Park had a higher relative frequency of small boulders (>256 mm). In unrestored area, we would expect to have larger debris armoring banks at bankfull width, while restoration efforts may have reduced these larger substrate size classes. The riffle section of Upstream Buckingham may have had higher relative frequencies of smaller substrate compared to Buckingham Park due to restoration efforts.

Figure 5. The 2018 particle size class (mm) and cumulative sediment distribution (%) of substrate at the Buckingham Park and Upstream Buckingham riffle cross sections on Left Hand Creek, Boulder County, CO. D₅₀ dashed line indicates the particle size at which 50% of all samples were equal to or less than.

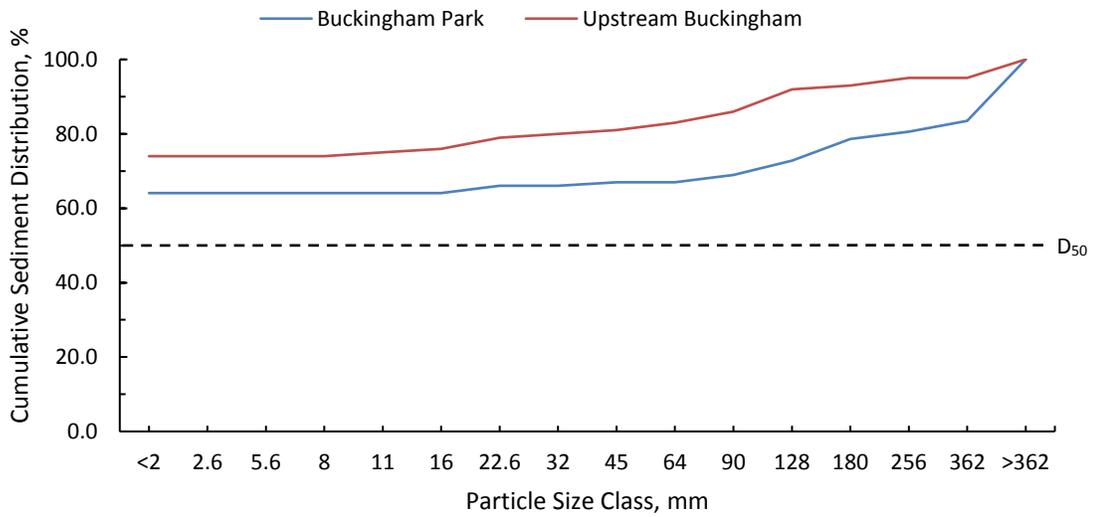
At the pool cross sections at both sites were similar in sediment distribution. Upstream Buckingham and Buckingham Park pools were composed of 74% and 66% sand (<2 mm), respectively (Figure 6). The pool at Upstream Buckingham is located on a river bend, while the pool at Buckingham Park is within a straight section of stream. Upstream Buckingham may have greater deposition due to slower velocities at the river bend. Lastly, since both pools were greater than 50% sand, it is likely that most of the sand deposition in these pools will mobilize at bankfull flushing rates.

Figure 6. The 2018 particle size class (mm) and cumulative sediment distribution (%) of substrate at the Buckingham Park and Upstream Buckingham pool cross sections on Left Hand Creek, Boulder County, CO. D₅₀ dashed line indicates the particle size at which 50% of all samples were equal to or less than.

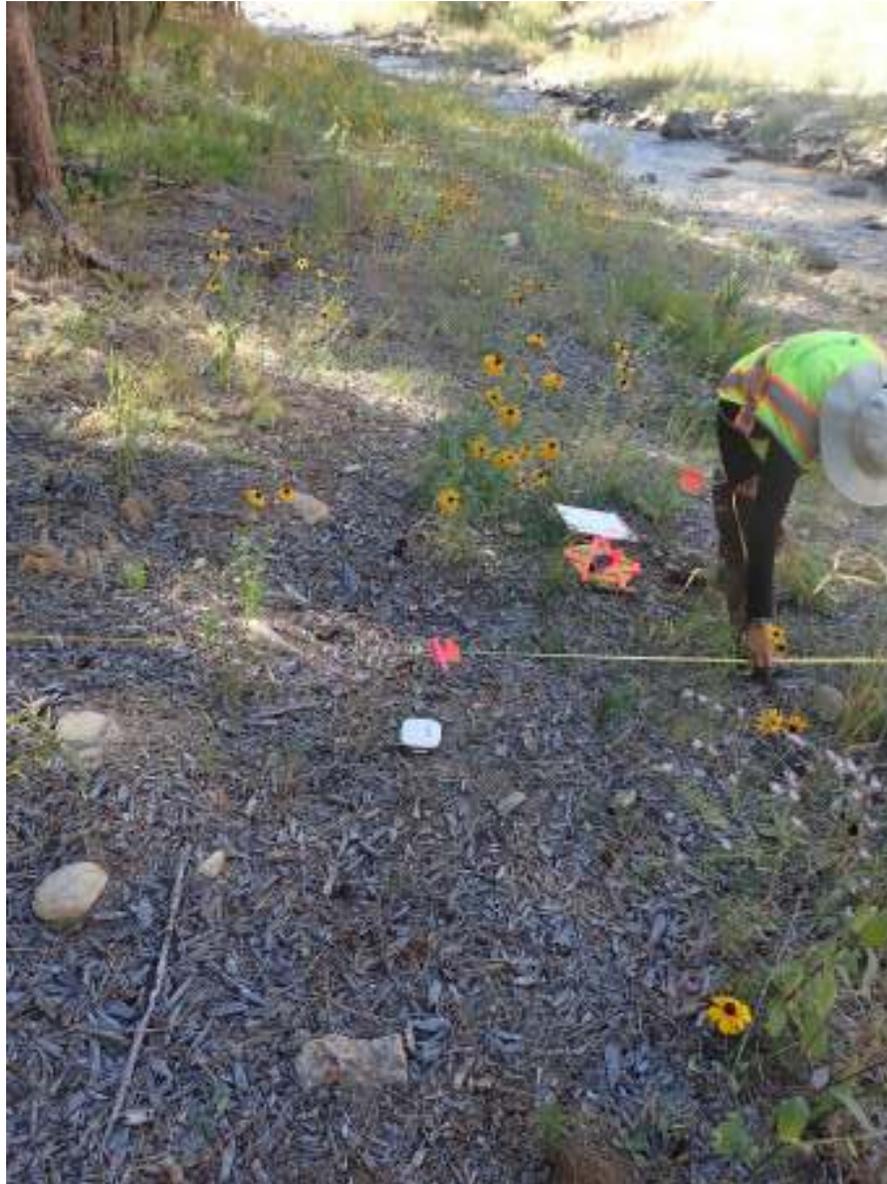
Although US Buckingham showed more native stem cover, the percent bare ground was high. LWOOG restoration project sites typically include a maintenance and monitoring warranty of revegetated sites that outlines stem cover thresholds for the first three years post-restoration. From these suggested thresholds, we expect greater than 30% stem cover one year after seeding. After one growing season, the US Buckingham site had 45% or less stem cover, with the majority of plots falling within this warranty. Bare ground at this site was primarily comprised of the wood chip mulch used during reseeding (Figure 7). In comparison, the bare ground at the Buckingham Site was comprised by stream cobble, bedrock, and thatch.

Figure 7. Image from 2018 vegetation survey at the Upstream Buckingham riffle site on Left Hand Creek, Boulder County, Colorado. This image was taken from the right bank, floodplain plot. Bare ground is occupied by woodchips.

3. Reseed floodplain, riparian, and creekside vegetation zones at Upstream Buckingham

Revegetated zones are comprised of high percent bare ground compared to other LWOG project warranty standards. However, it does not appear that weeds are outcompeting native species at the Upstream Buckingham location. We observed low levels of pioneer weed species including sweet clover and invasive thistles in reseeded areas at Upstream Buckingham. Although we expect to see succession in plant communities each growing season, the lack of non-native species at this specific location provides an excellent opportunity to strengthen the native plant community. Due to high percentages of bare ground, we suggest reseeding the floodplain, riparian, and creekside zones as early as spring 2019. By continued monitoring, there is an added benefit of quantifying revegetation with low presence of weeds.
